# TRACKING POLYCHLORINATED BIPHENYLS IN THE MILLERS RIVER BASIN, MASSACHUSETTS

During the summer and fall of 1999, the U.S. Geological Survey measured polychlorinated biphenyl (PCB) concentrations in passive samplers deployed in the Millers River Basin in Massachusetts. The observed PCB concentrations and congener-pattern changes indicated a historical release of PCBs likely occurred on the Otter River at the upstream margin of Baldwinville, Massachusetts. PCB concentrations decreased significantly downstream of the confluence of the Otter River with the Millers River because of dilution of Otter River water with mostly uncontaminated water from the Millers River and volatilization of PCBs in steep reaches of the Millers River. The PCB load in the Millers River was relatively small compared with PCB loads in other PCB-contaminated rivers in the Northeast. The likely source of PCBs in the Millers River Basin is the remobilization of PCBs associated with stream sediments. PCBs deposited on the sediment likely originated from an upstream source. Estimated concentrations of PCBs in water throughout the main stems of the Millers and Otter Rivers exceeded the U.S. Environmental Protecti

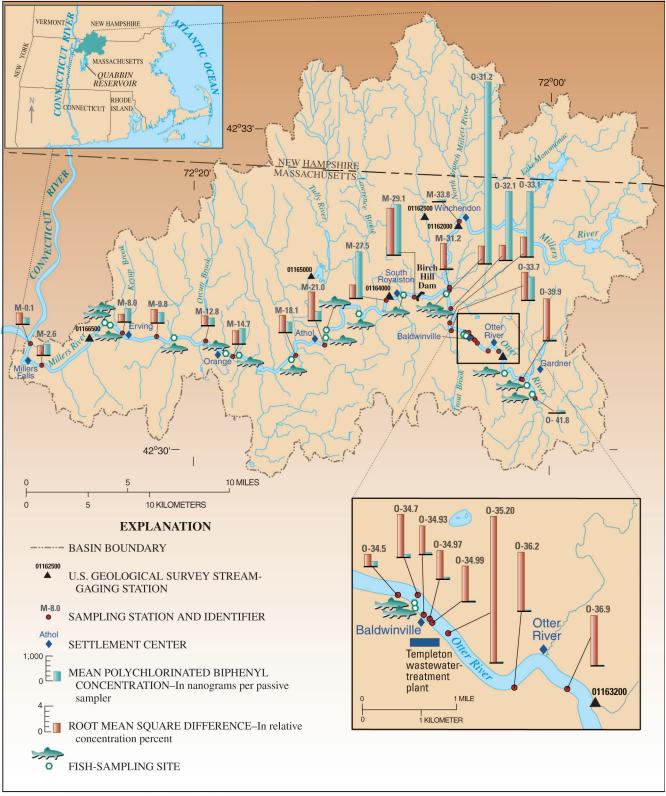
**Figure 2.** Passive-sampler deployment and fish-sampling sites, mean polychlorinated biphenyl (PCB) concentrations, and change in congener patterns along the Millers and Otter Rivers, Massachusetts. PCB concentrations increased and congener patterns changed in the downstream direction beginning at river mile O-35.2. In this study, a river mile refers to the distance from the confluence of the Millers River with the Connecticut River to the sampling station, as measured along the river channel. The sampling station is named with the first letter of the river on which the station is located and the river mile. For example, the sampling station on the Otter River that is 36.2 miles from the confluence of the Millers River with the Connecticut River is named O-36.2.

(fig. 1). Results from these samplers, which absorbed PCBs over a 2-week period, were obtained at 26 stations in the Millers and Otter Rivers (figs. 1 and 2), to identify the reaches most likely to be source areas leading to exposure of fish to dissolved PCBs (Colman, 2001).

Clear trends were present in the PCB distribution resulting from the passive-sampler analyses (Colman, 2001). In the Otter River, PCB concentration increased substantially in the downstream direction, beginning at river mile O-35.2, with the greatest concentration measured in the entire basin occurring between river miles O-32.1 and O-31.2 (fig. 2). The maximum change in the PCB-congener pattern, as indicated by statistical analysis of sample results, was determined to be farther upstream, between river miles O-36.2 and O-35.2. Also, a large relative increase in PCB concentrations in the Otter River coincided with the pattern change between river miles O-36.2 and O-35.2.

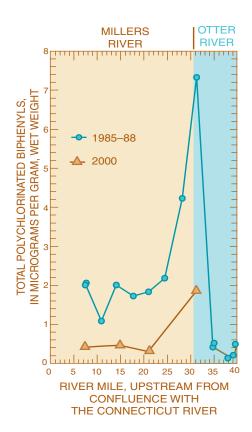
Figure 3. Polychlorinated biphenyl concentrations in fish tissue sampled from the Millers and Otter Rivers, Massachusetts. Concentrations in fish were four times less in samples collected in 2000 than in samples from previous studies.

In addition to the passive-sampler survey, average daily loads of PCB congeners were calculated from composite river-water samples collected at a USGS stream-gaging station in South Royalston, MA (USGS stream-gaging station 01164000). In 2000, white suckers (*Catostomus commersoni*) were collected at four sites and their tissue analyzed for total PCB concentration as Aroclors. These data were compared to fish-tissue data from white suckers collected in 1985-88 (fig. 3).

Although the estimated fishexposure levels exceeded the USEPA water-quality criterion through much of the study area during this investigation, PCB concentrations in fish, as determined by a survey of white suckers, have declined since earlier investigations were conducted. Concentrations of PCBs in fish-tissue samples collected in 2000 were four times less than concentrations found in samples collected from 1985–88 (Robert Maietta, Massachusetts Department of Environmental Protection, written commun., 2001).

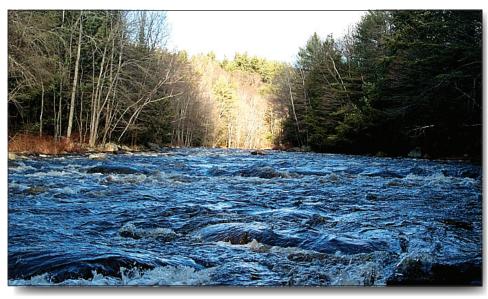
**Figure 4.** A section of turbulent water on the Millers River, Massachusetts, at river mile M-26.5. As the river tumbles through these steep sections, dissolved PCBs can escape from the water into the air.

Below the confluence of the Otter River with the Millers River, PCB concentrations decrease by a factor of four (Colman, 2001). Dilution from the relatively uncontaminated upstream Millers River most likely causes this decrease. In steeper gradient, more turbulent sections of the river (river miles M-27.5 to M-21.0 and M-8.0 to M-0.1; fig. 4), volatilization, the escape of PCBs from water into the air, may also account for the decrease in concentrations.

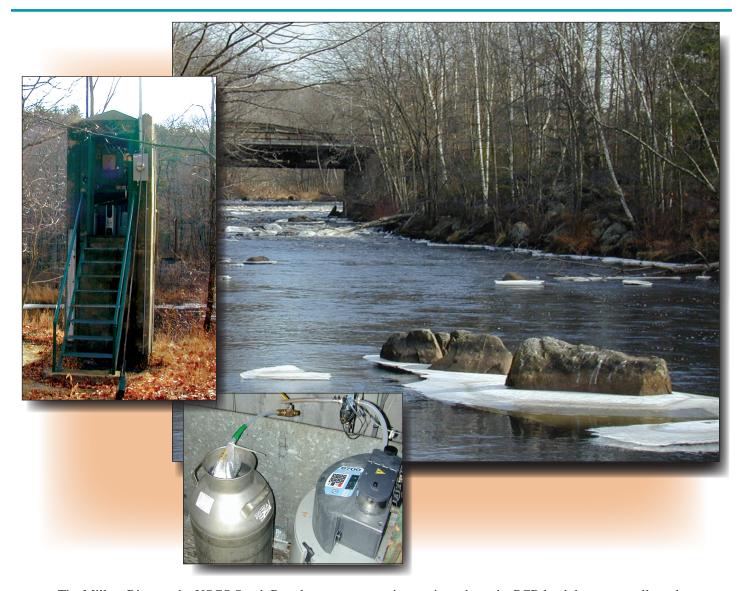
The Millers River at the USGS South Royalston stream-gaging station where the PCB load data were collected.

The PCB load is the mass of dissolved PCBs and PCBs associated with suspended particulate matter passing by a specific point over a given time interval. The PCB load determined from samples collected by the USGS on the Millers River at South Royalston, MA (USGS stream-gaging station 01164000), was about 9 pounds per year. This result, distributed between the dissolved phase and suspended
